NATIONAL ADVISORY COMMITTEE FOR AERONAUTICS

SHEAR-LAG TESTS OF TWO BOX BEAMS

WITH FLAT COVERS LOADED TO DESTRUCTION

By Patrick T. Chiarito

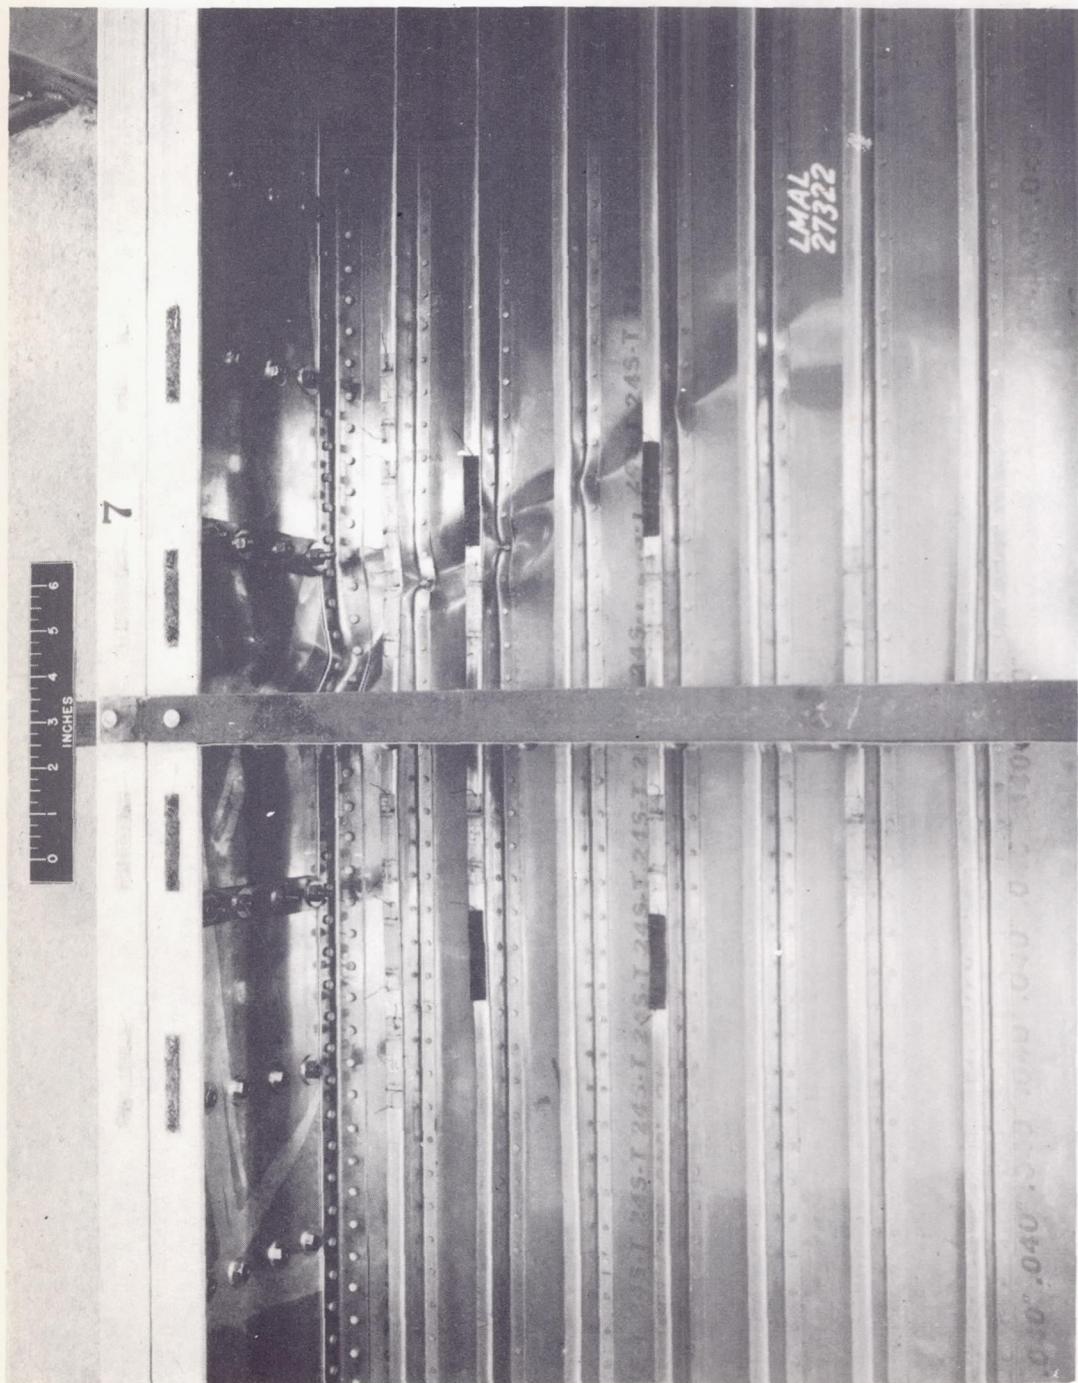
Fig. 8

Failures of beams.—The failure in beam 1, which occurred at a jack load of 14,300 pounds with the distributed-load condition, is shown in figure 8. The corner flange failed first, followed by failure of the adjoining stringers. In order to prevent extensive damage of the specimen the jack load was released at an early sign of destruction. The stringer next to the flange was nevertheless torn near a rivet. The stringer along the longitudinal center line (stringer 9) was disjoined from the bulkhead at the root. This bulkhead suffered bad distortions at several places near the stringers; these distortions indicated the existence of large secondary bending forces. In the second beam the root bulkhead was attached to the stringers by a 1-by 1-by 1/8-inch steel angle.

Strength of corner flanges.—The calculated ultimate stress, in the flange at the root station, for beam 1 was 47,400 pounds per square inch; whereas 50,450 pounds per square inch was calculated for beam 2. These values are quite close to the column yield stress of 50,000 pounds per square inch (reference 3, fig. 5-1).

At failure the maximum Mc/I stress was 24,400 pounds per square inch for beam 1 and 29,000 pounds per square inch for beam 2. These values may be interpreted to mean that the stringers were first to fail, with average fixity coefficients of 1.08 and 1.61, respectively. Inspection of the various parts of both beams under load, however, showed that failure first occurred in the corner flanges. The fallacy of the argument that the stringers failed by instability is obvious also because increasing the area of the corner flange can hardly be expected to increase the fixity coefficient developed by the stringers.

Figure 8.- Failure at root of beam 1.

For the first series of tests the box was of constant cross section throughout. After failure the corner flange was reinforced for a length of 22 inches on either side of the root by another angle formed from 0.064-inch sheet and the second series of tests was performed. When the box was being rebuilt, the cover was moved $1\frac{1}{2}$ bays longitudinally, and the surplus at one end was cut off and spliced to the other end. Thus, the previously damaged part of the cover was moved to a point of comparatively low stress. New corner-flange angles were used.

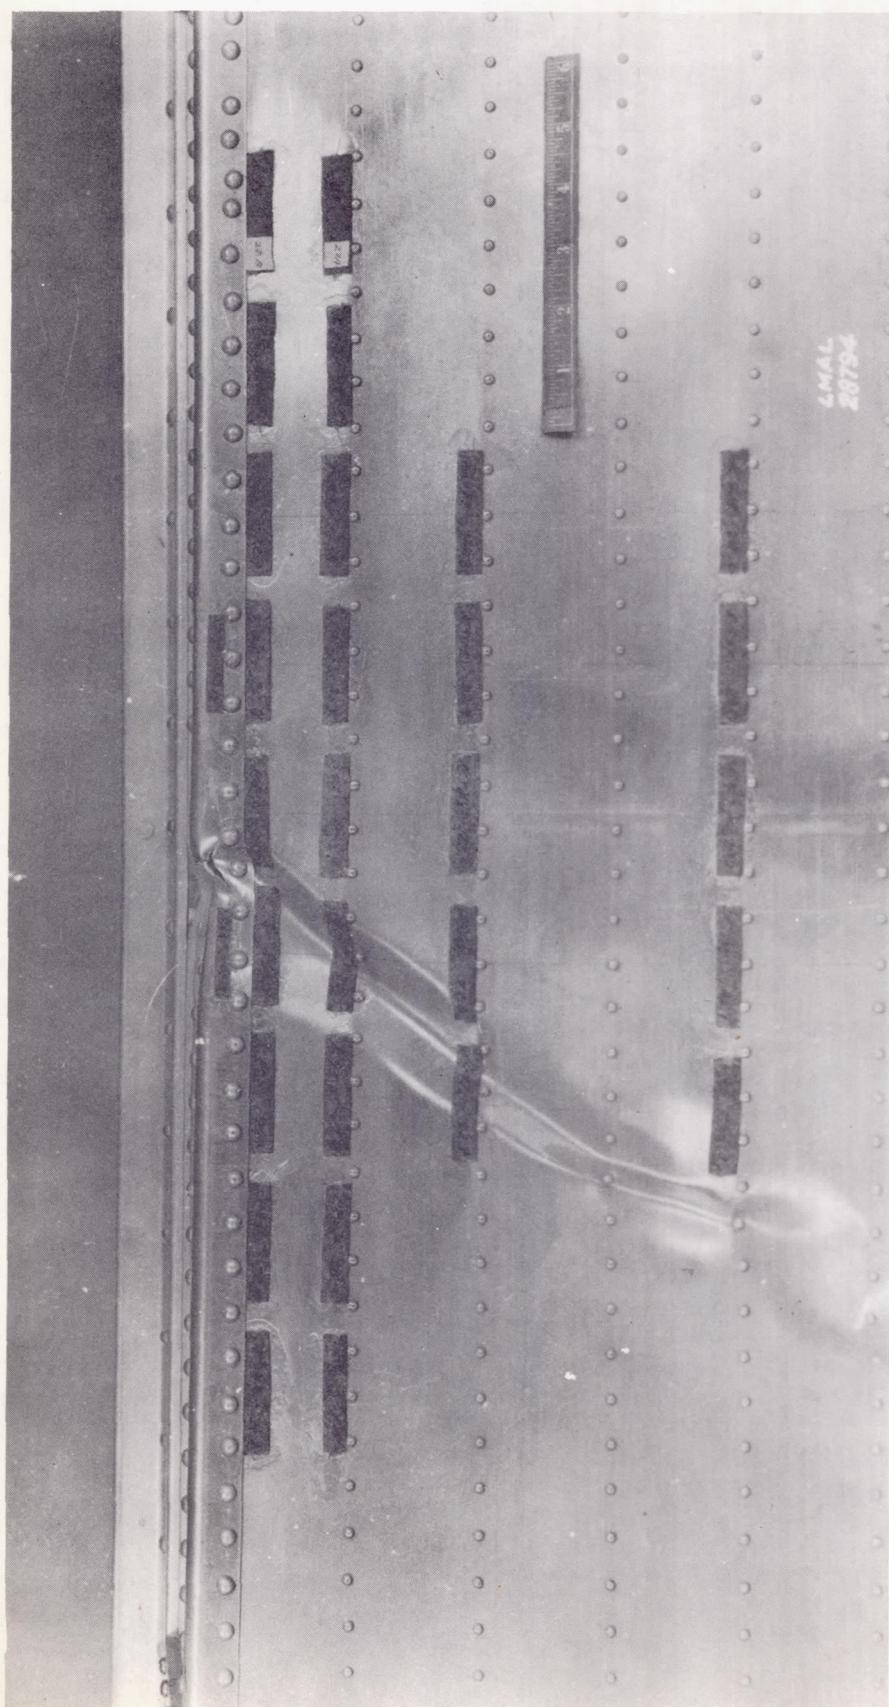
Fig. 9

Beam 2 failed at a jack load of 17,900 pounds with the distributed-load condition. Figure 9 shows the details the failure. As in beam 1 the flange was first to fail, followed by the failure of several adjoining stringers. Unlike beam 1, which failed gradually, beam 2 failed very suddenly. The corner-flange material was torn, as was the material in the three adjoining stringers. In contrast to the stringers of beam 1, all the stringers remained attached to the bulkheads.

Figure 9.—Failure at root of beam 2.
